# **EXHIBIT D**

# Lead Cable Investigation

June 30, 2023

Marine Taxonomic Services, Ltd.  
Below the Blue 501(c)3

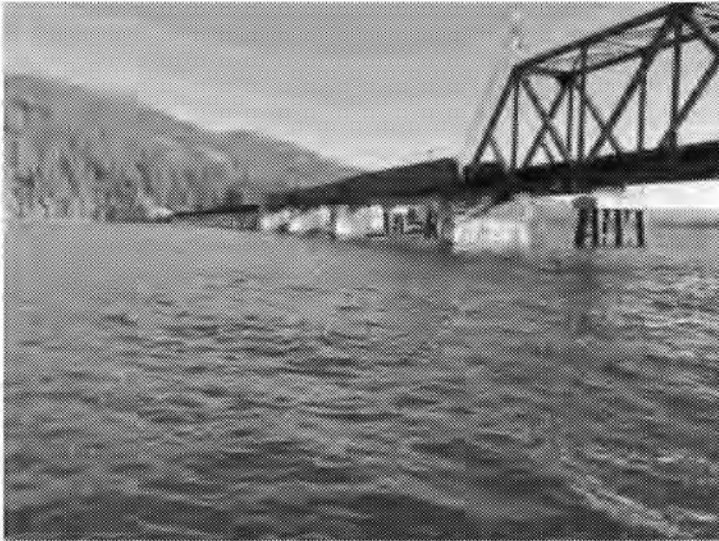
(A) Lake Pend Oreille, ID Railroad Bridge. August 2022.

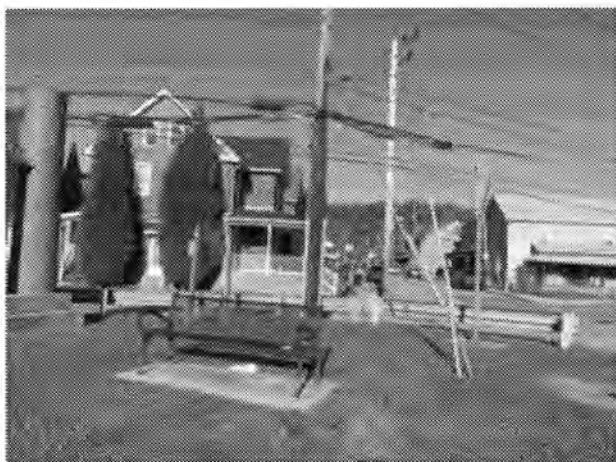
(A) Park bench near exposed lead sheathed cables and splice boxes. October 2022. Natrona, Pennsylvania.

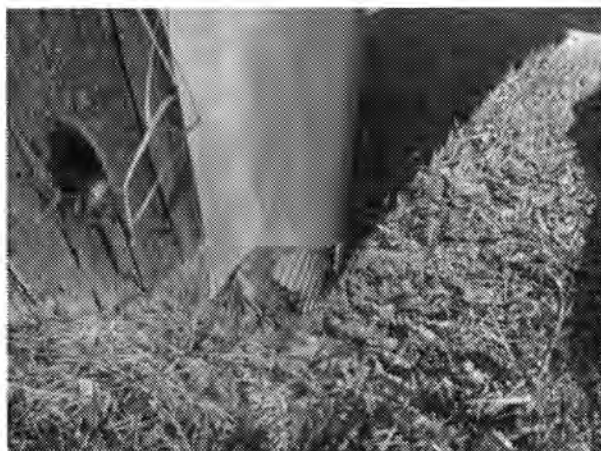
(B) Base of telephone pole in (A) and (C) showing marked cable going into the ground. October 2022. Natrona, Pennsylvania.

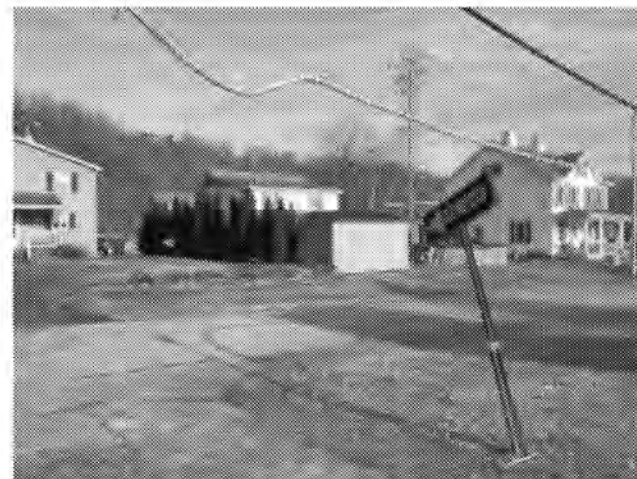
(F) CT11. Overhead lead sheathed cable running through a residential area near the end of town. February 2023. Coal Center, Pennsylvania.

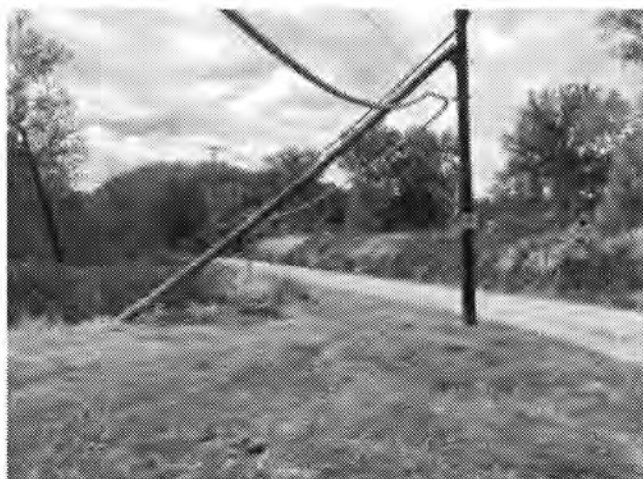
(E) CT8. Overhead lead sheathed cable running across a greenway and sidewalk. February 2023. Coal Center, Pennsylvania.

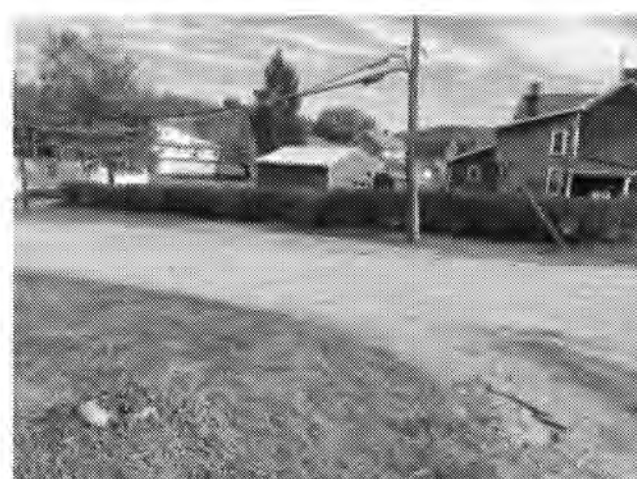
(G) CT12. Overhead lead sheathed cable running across the road next to homes. October 2022. Coal Center, Pennsylvania.

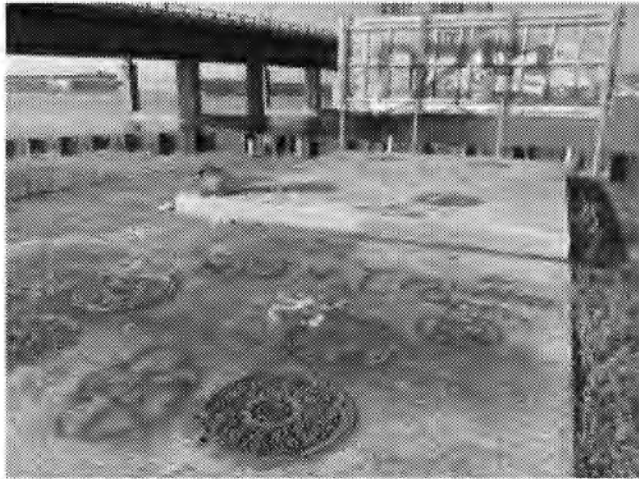
(A) Large vault with eight Bell Systems manholes on the Hackensack River. Looking towards South Kearny. January 2023, West Side, New Jersey.

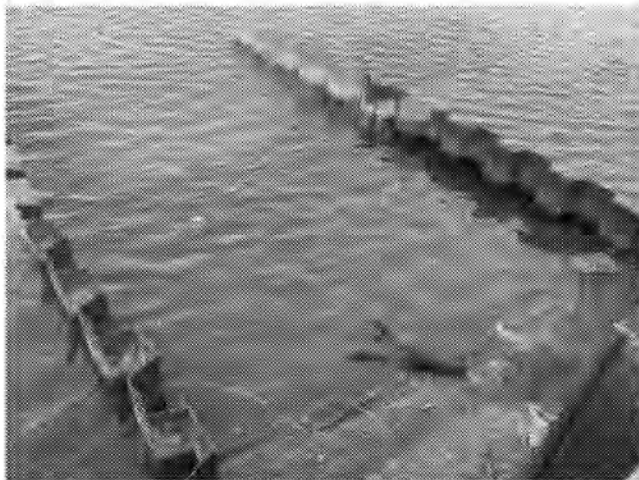
(B) Cable landing area covered with concrete. Area is below the sign in (D). January 2023, West Side, New Jersey.

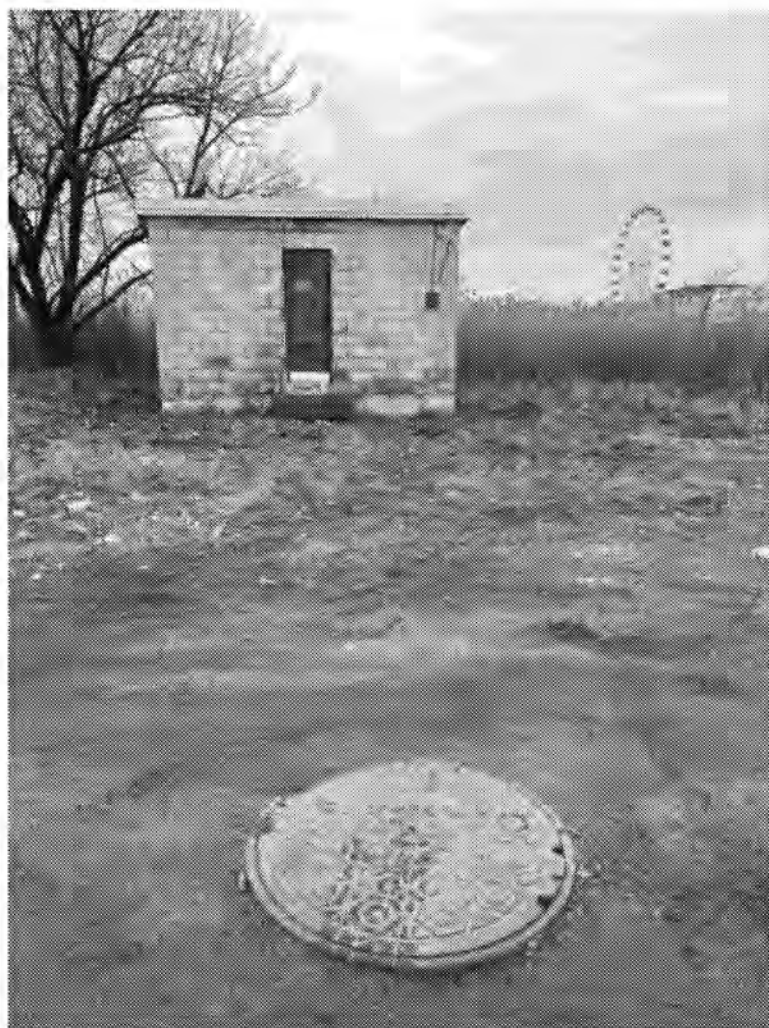
Figure 21. Photos. New Jersey continued, (E) Largely abandoned area around the Meadowlands, Old Bell Systems manhole and utility building. (F) Concrete casing that would have laid on top of the old lead sheathed cable. This is like those found on the Detroit River, Location 1. (G) Newer AT&T flagging found a few feet away from the building, Hackensack 3.2. January 2023, Meadowlands, New Jersey.

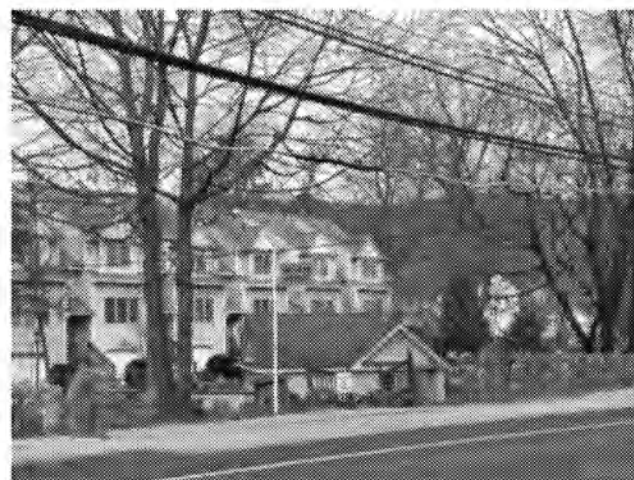
Four generalized data points were recorded for Highland Falls Township. Lead sheathed cable appears to run throughout the town and is occasionally covered with a protective sheathing that encompasses parts of the cable. Visible bare leaded splice boxes were observed at nearly every telephone pole. (Figure 25(A-C)). This site required more time than was available for detailed observations and further investigation is recommended.

(B) Overhead lead sheathed cables in front of an apartment complex. January 2023. Highland Falls, New York.

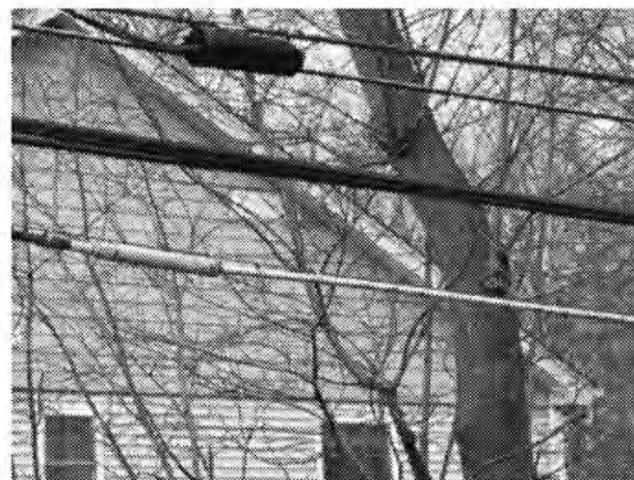
(C) Exposed bare lead splice box and lead cable. January 2023. Highland Falls, New York.
